Office of Transport Safety Investigations

RAIL SAFETY INVESTIGATION REPORT

DERAILMENT OF PACIFIC NATIONAL SERVICE MC92

23 NOVEMBER 2011

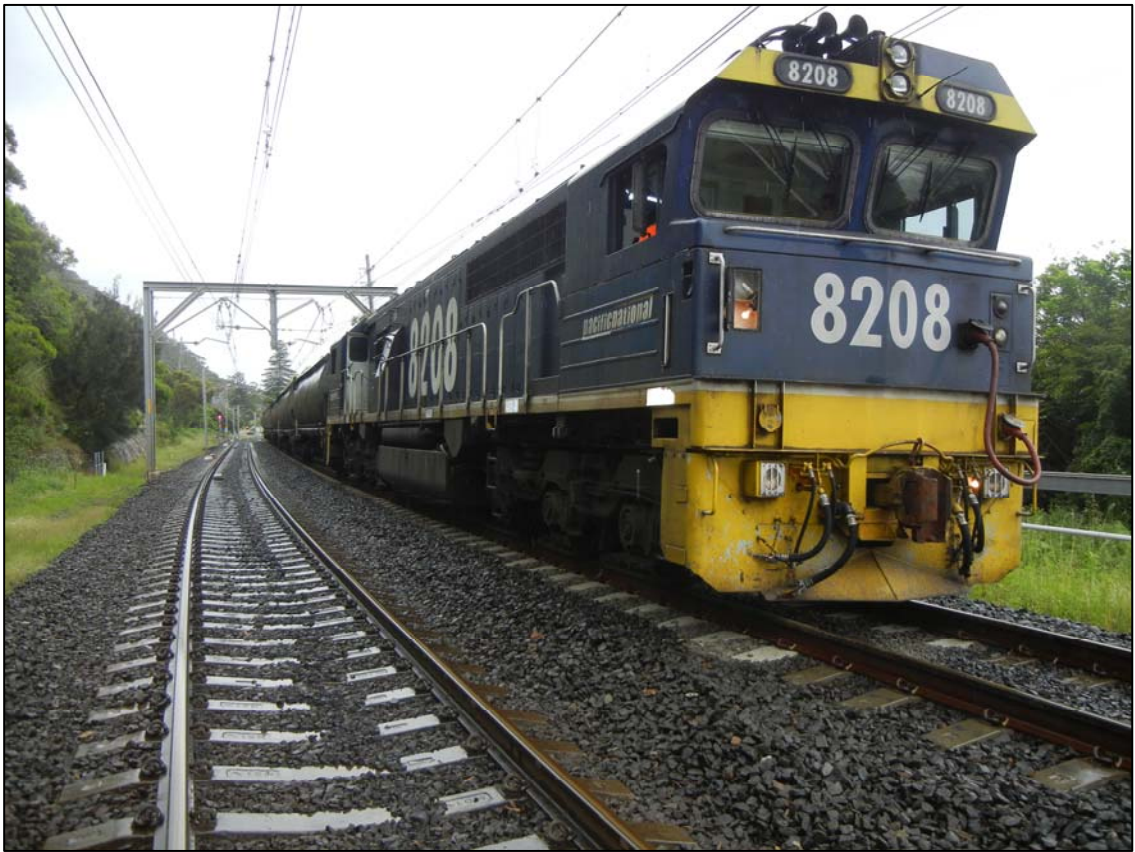
Photograph 1: Train MC92 past Clifton level crossing

- 1.3 Coal train MC92 was owned and operated by Pacific National, a division of Asciano Limited. It was in a push-pull configuration consisting of a single locomotive (8208) at the lead (see *Photograph 1*) and another single locomotive (8206) at the rear, with 45 loaded coal wagons in-between. The wagons were a mixture of 3-pack NHFF, NHSH and NHJF rakes. Each wagon had an estimated gross mass of about 90 tonnes. The train measured 799 metres and weighed 4740 tonnes.

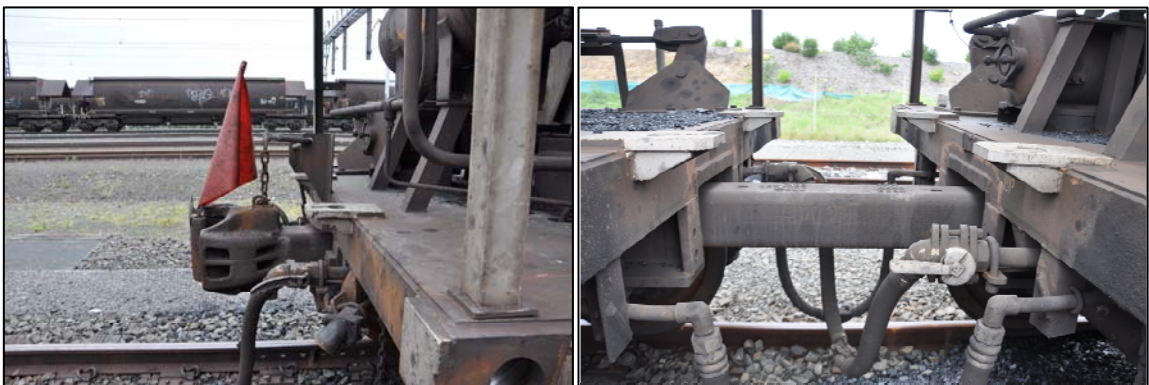
Photograph 2: Knuckle coupler and drawbar coupler

- 1.4 The wagon with the broken axle, NHFF 42702K, was the eighth wagon of 45 wagons in the train; it was the middle wagon of a rake of three wagons permanently coupled together with bar couplings (see *Photograph 2 right*). Both ends of the rake had standard automatic coupler arrangements (see *Photograph 2 left*).

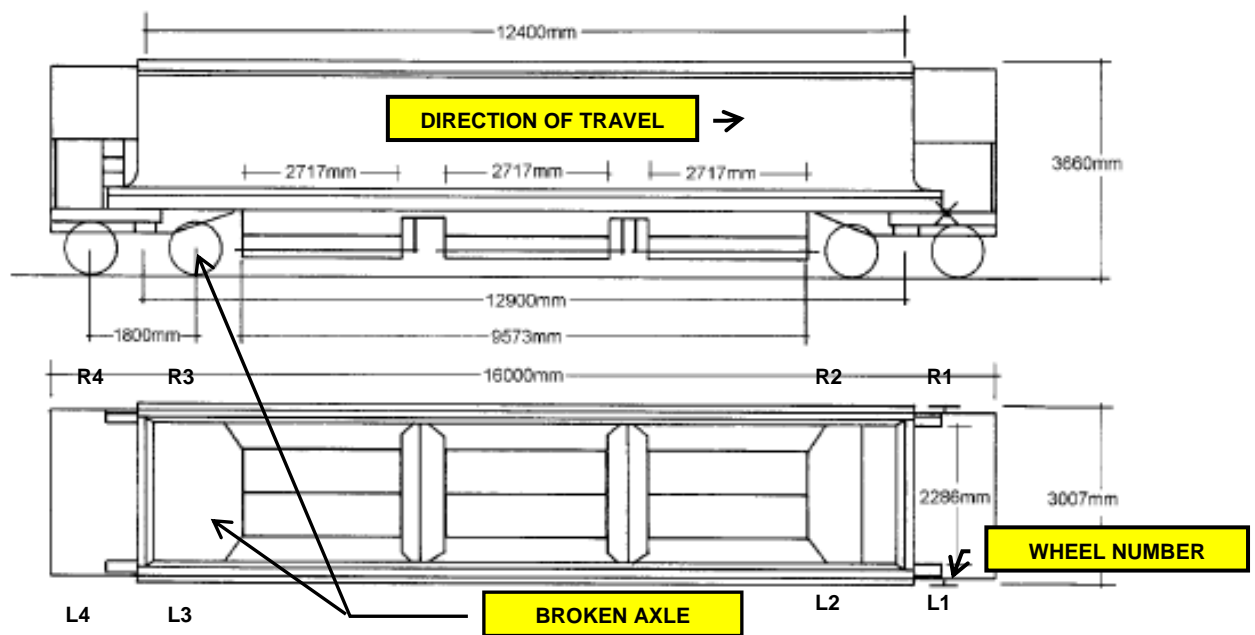
Figure 5: NHFF wagon with wheel numbering

- 1.21 A break in the No. 3 axle from the eighth position wagon was identified as an initial causal factor (see *Figure 5*). Half of the broken axle remained in-situ under the wagon with the other half found in the four foot approximately 70 metres away. As this part was exposed to the elements it was covered by plastic to protect it for later examination. A number of bogies, wheelsets and both sections of the broken axle were recovered and examined at Pacific National wagon maintenance facilities at Port Kembla. OTSI investigators witnessed the initial examination of the broken axle by a metallurgist who took samples of the axle for metallurgical examination.

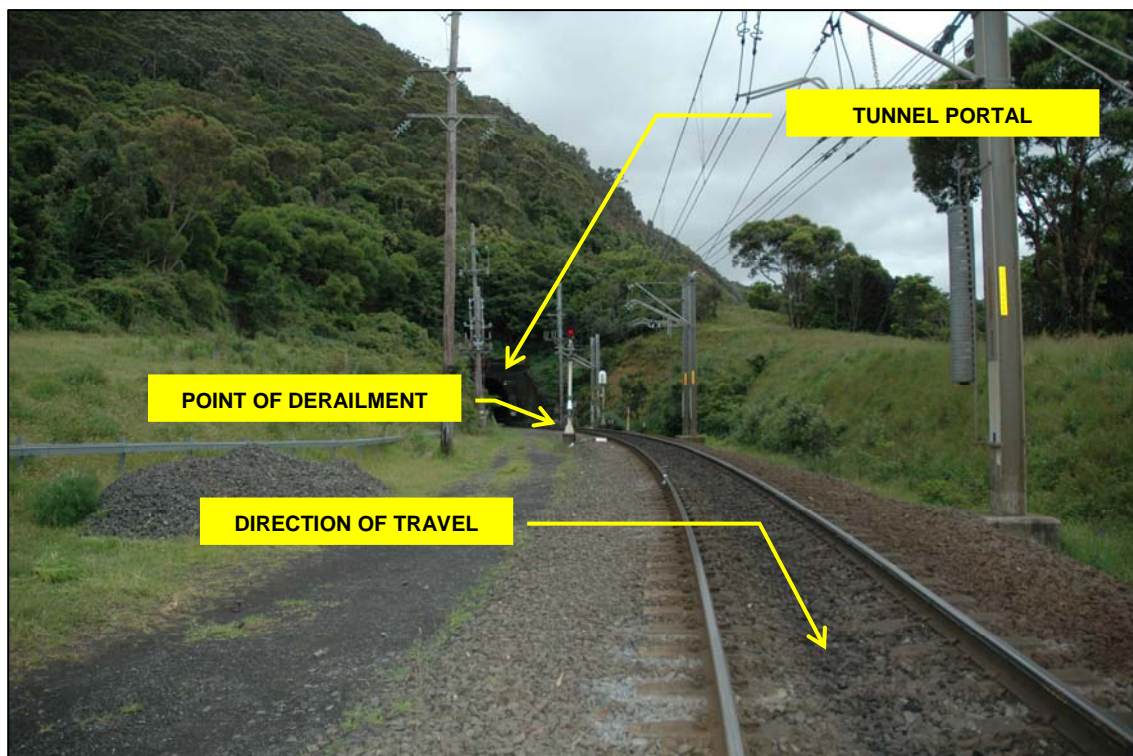
Photograph 6: Tunnel portal

2.1 Pacific National Coal Train MC92 derailed because the barrel of the No. 3 axle on the eighth wagon (NHFF 42702K) broke. The breakage caused the wheelset to come apart and both wheels to derail. The left-hand side wheel and axle section detached from the bogie and was tumbled under the trailing wagon. As a consequence, the train derailed as it exited the tunnel at kilometrage 61.351, approximately 23 metres South of the tunnel portal (see *Photograph 6*). The train continued for a further 350 metres in a derailed state, with various wheels running on and damaging the concrete sleepers. Derailment forces also caused the rails to break and detach from the sleepers. The rail breaks occurred at those locations where the rail was welded (or in the heat affected zones of those welds).
